# Multiple Failures in Roosevelt High School HVAC System

March 30, 2023

A report by RSM US LLP for the Office of the D.C. Auditor

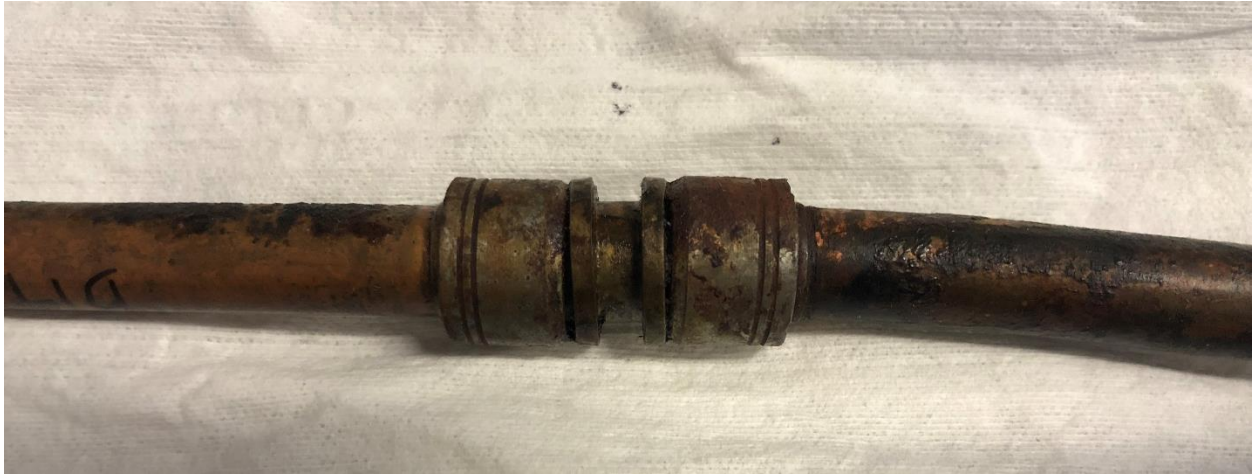
**Fig.2: B141 Sample Received from Gilbane Company**

When the products were received a visual inspection was done and it was found that B141, B149, B150A & B150B all had external rings not seated properly on the external stop of the coupling body. Which could lead to an uneven distribution of LOKPREP within the coupling and damaging of the coupling body due to pressure not being evenly distributed across the flange face. The straight connectors that failed the leak test were cut apart and inspected for proper installation of LOKPREP. The connectors B141 (Fig. 8), B149 (Fig.9), B150A (Fig.10), and B150B (Fig. 11) all showed low levels of LOKPREP on various sides of each connection and are highlighted in each figure respectively.

Based on the results from the visual inspection performed it can be concluded that any potential leaking in the samples may have been a result of insufficient amounts of LOKPREP and improper installation. (Fig. 6) shows an example of a 16-size straight connector with appropriate levels of LOKPREP and has been tested using our LOKTRACE hydrogen leak detector that showed not to leak.
