**INSPECTION, TESTING, AND MAINTENANCE OF FIRE AND LIFE SAFETY SYSTEMS
AT THE YOUTH SERVICES CENTER AND
NEW BEGINNINGS YOUTH DEVELOPMENT CENTER**

Report 2025 – 1

MARCH 31, 2025

OFFICE OF INDEPENDENT JUVENILE JUSTICE FACILITIES OVERSIGHT

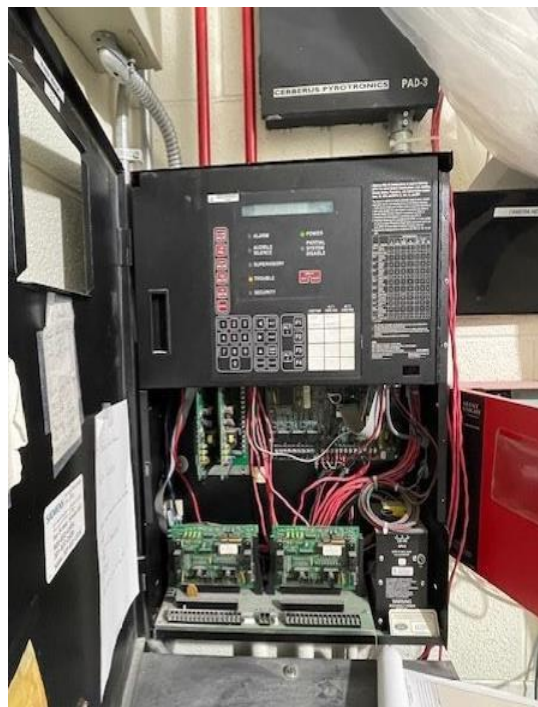
The existing fire alarm system is a voice evacuation Siemens MXL system presumably installed when the building was constructed circa 2004. The Siemens MXL was originally introduced to the market in the 1990’s. The manufacturer offered this type of system through October 1, 2013. System parts and components were provided for a five year period from 2013 until 2018. MXL detectors and devices were available for a ten year period from 2013 through 2020. The system is no longer officially supported by Siemens and replacement parts are no longer manufactured.

The fire alarm system at YSC consists of a main fire alarm control unit (FACU) located in the Central Control Room 1102, which is currently under construction.¹ Initiation of alarm is accomplished via initiating devices such as: smoke detectors, manual pull stations, duct smoke detectors, sprinkler water flow switches, etc. Notification is accomplished throughout the facility via strobes and fire alarm speakers. Upon alarm, the speakers emit a temporal-3 alert tone, followed by a pre-recorded voice message.

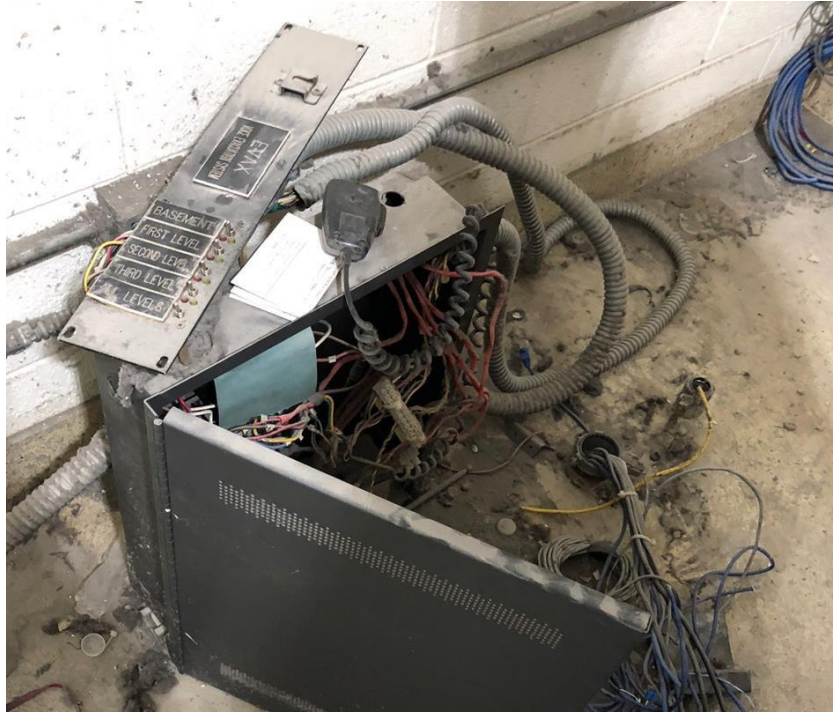
The system is connected to an EVAX brand panel, which is also located in the Central Control Room 1102. The EVAX panel contains the amplifiers for the voice evacuation announcements. A microphone is provided at the EVAX panel along with selector switches to allow manual paging to the Basement, First Floor, Second Floor, or all floors.

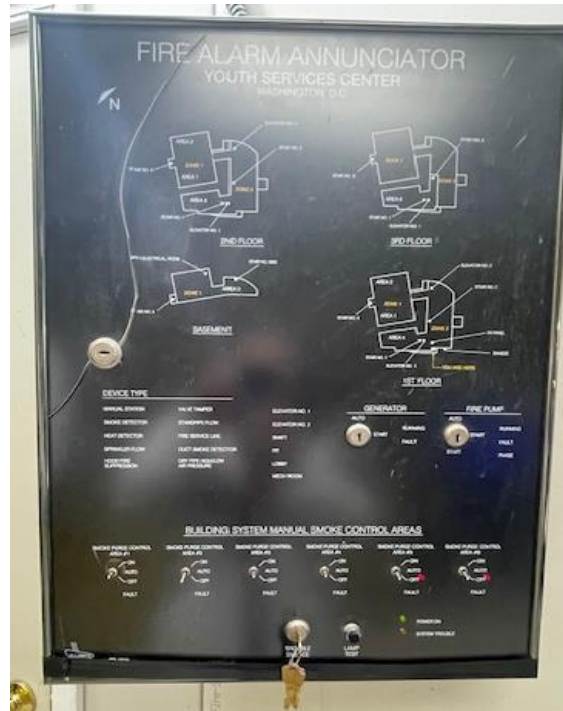
A graphical annunciator panel is provided near the main entrance to the facility on that level.² The annunciator provides a graphical representation of each floor along with LED lights to convey the type of alarm and location of the alarm within the building. There are also switches on the annunciator for manually controlling smoke control fans in the building.

² The main entrance at the time of the test was a temporary entrance that is being used during a facility renovation project. YSC staff reported that the annunciator panel was moved from Control to the entrance area for the duration of the renovation project.
