# Multiple Failures in Roosevelt High School HVAC System

March 30, 2023

A report by RSM US LLP for the Office of the D.C. Auditor

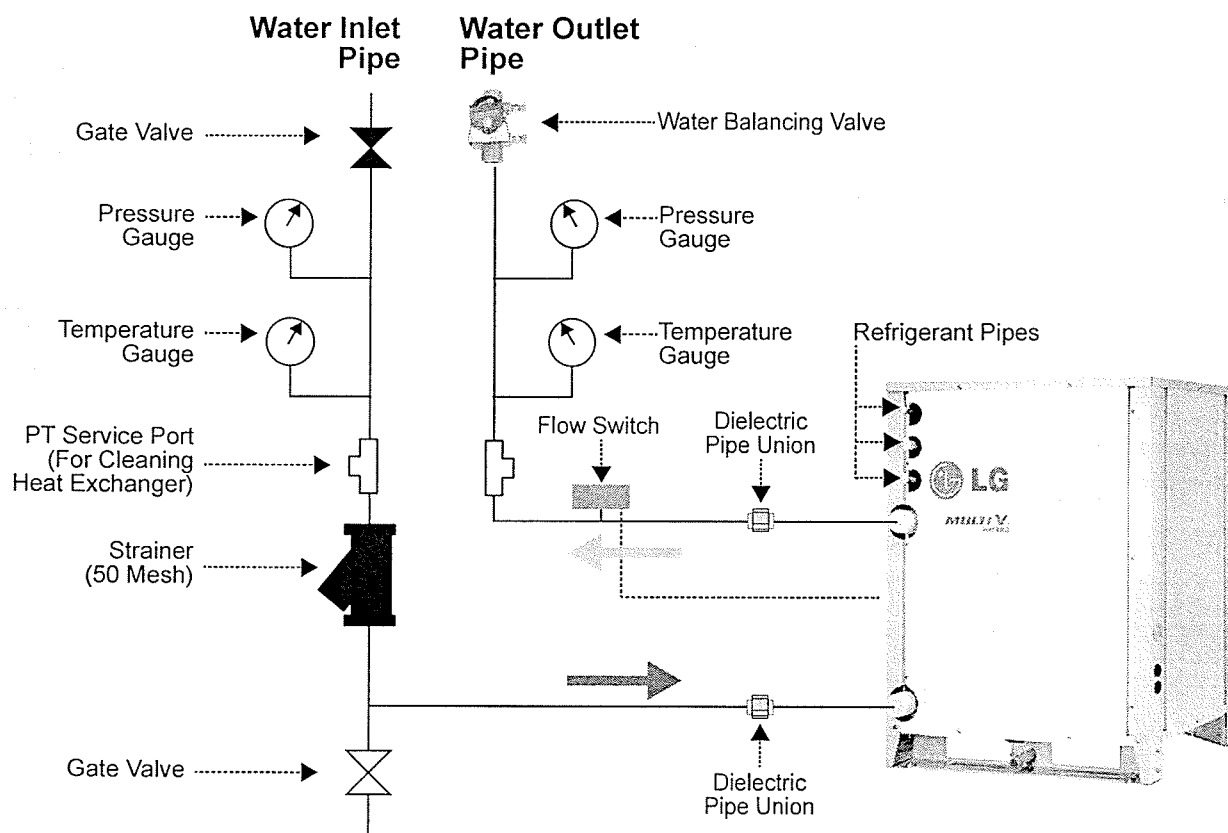
Figure 53: Typical Field-Supplied Components and Connections for Multi V IV WSU.

As shown in Figure 53, the following field supplied components should be installed at each Multi V IV Water Source Unit:

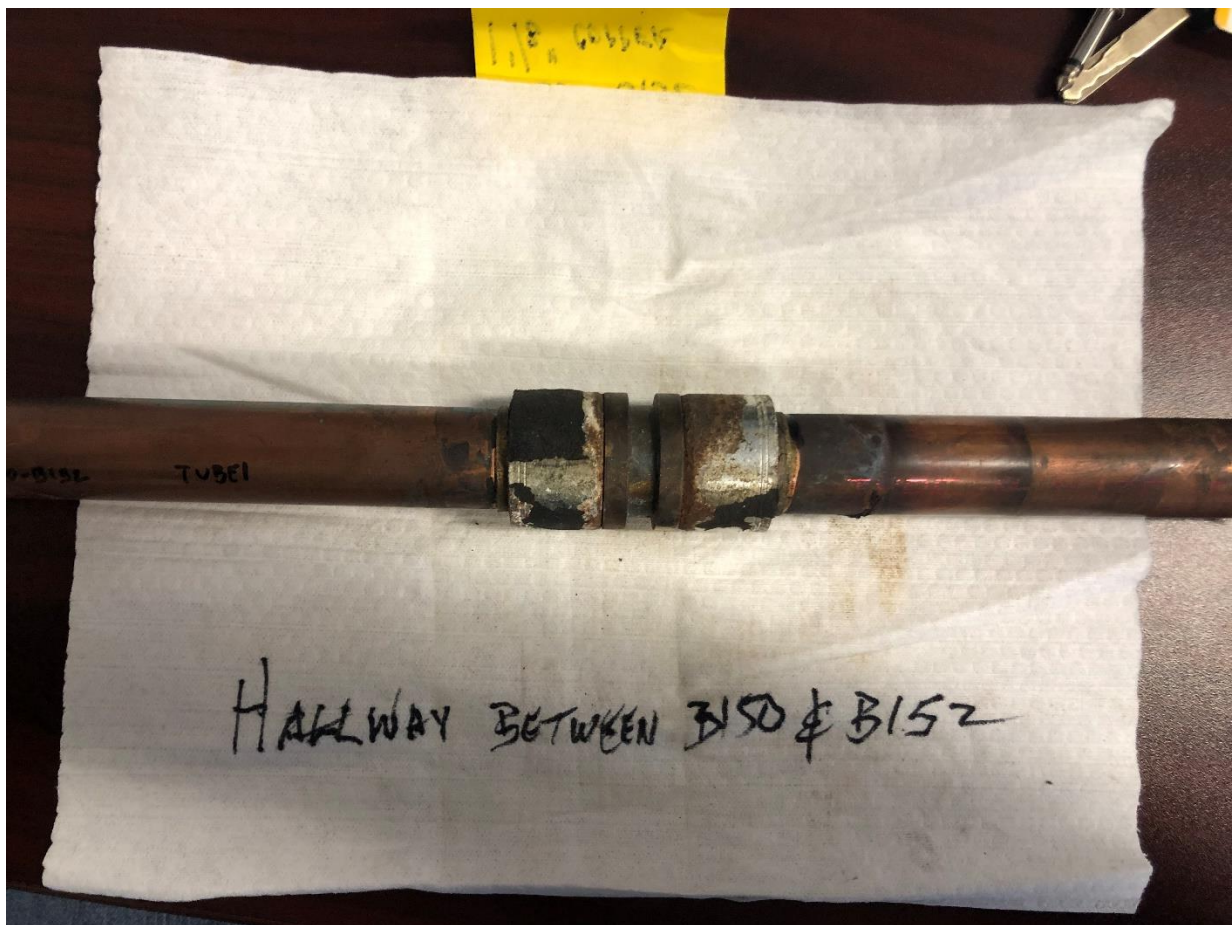
**Fig.1: 1 1/8 Connector Sample Received from Gilbane Company**

All samples were tested for leaking except the 5/8 connector due to testing equipment constraints. The testing used a hydrogen/nitrogen gas mixture pressurizing the tubes to 300 psi and used our LOKTRACE hydrogen leak detector. Video was taken of each test and are provided with the report. The samples that failed the leak test were then cut apart and visually inspected for LOKPREP distribution and proper installation. The LOKPREP distribution was inspected by placing the samples under a black light to illuminate the fluorescent LOKPREP and inspected if the application of LOKPREP was enough and if leak paths were present.

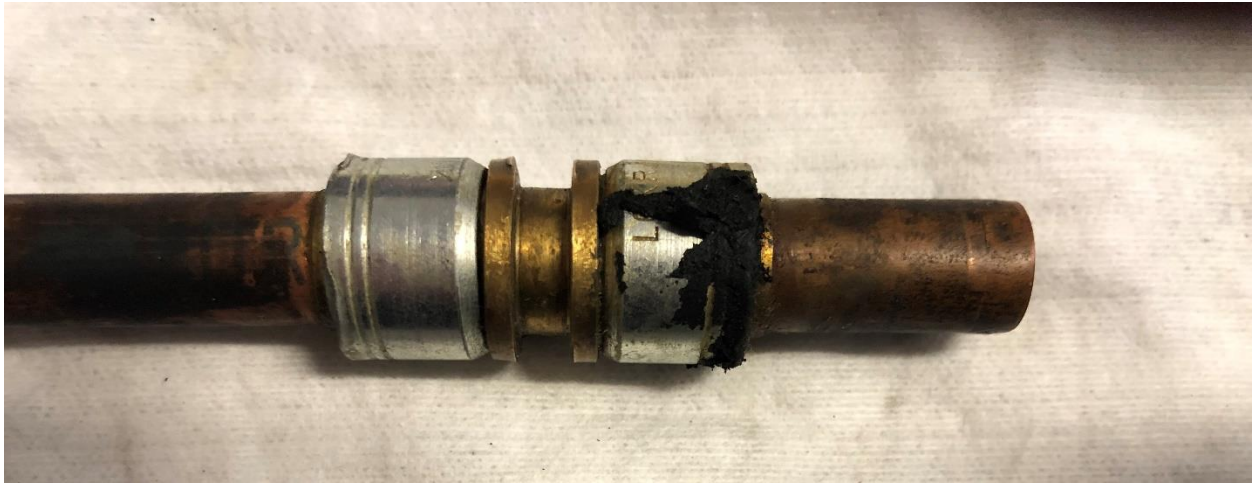
**Fig.6: B152 Sample Received from Gilbane Company**

Based on the results from the visual inspection performed it can be concluded that any potential leaking in the samples may have been a result of insufficient amounts of LOKPREP and improper installation. (Fig. 6) shows an example of a 16-size straight connector with appropriate levels of LOKPREP and has been tested using our LOKTRACE hydrogen leak detector that showed not to leak.

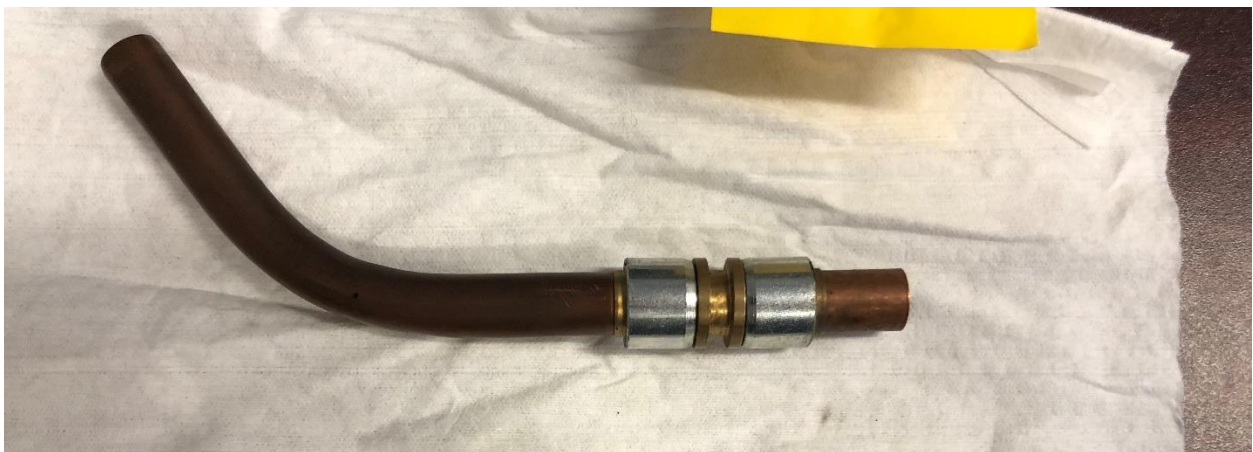
**Fig.7: B203 Sample Received from Gilbane Company**

When the products were received a visual inspection was done and it was found that B141, B149, B150A & B150B all had external rings not seated properly on the external stop of the coupling body. Which could lead to an uneven distribution of LOKPREP within the coupling and damaging of the coupling body due to pressure not being evenly distributed across the flange face. The straight connectors that failed the leak test were cut apart and inspected for proper installation of LOKPREP. The connectors B141 (Fig. 8), B149 (Fig.9), B150A (Fig.10), and B150B (Fig. 11) all showed low levels of LOKPREP on various sides of each connection and are highlighted in each figure respectively.
